Featured Projects

TEXAS - HOTEL

Pan Filled Metal Stair Replacement and Metal Stair Rail Salvage

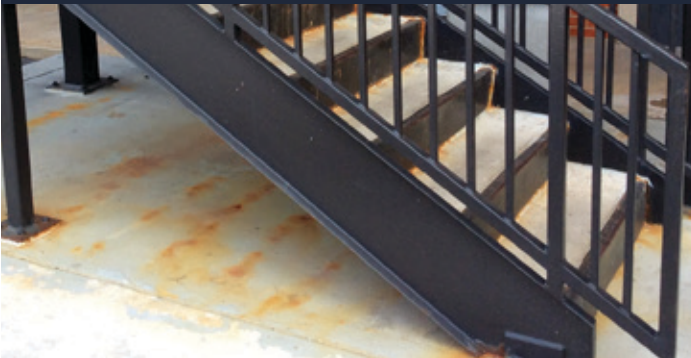
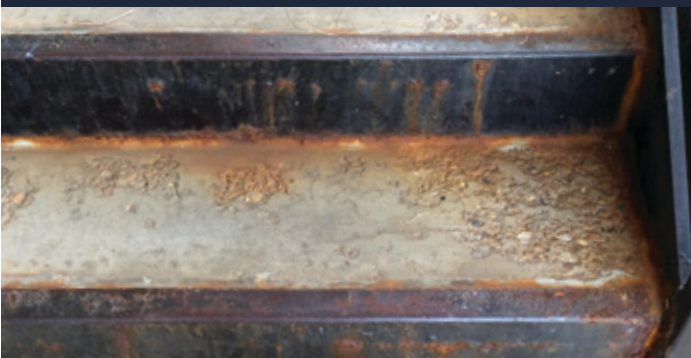
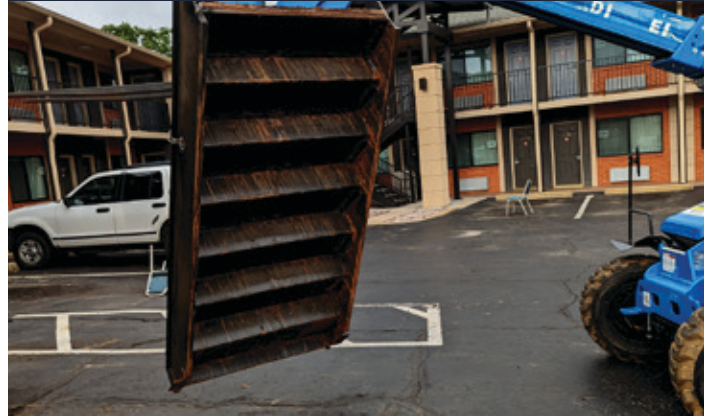
The original metal stairs experienced major corrosion created by rain and moisture exposure. Over time, the metal stairs became a curb appeal issue and ultimately the corrosion created an unsafe stair for hotel visitors. To save costs, the customer had a local metal fabricator remove the original stairs, remove the rail, fabricate new stair frames and reinstall the original rail. Perma-Tread was installed as an alternative to precast concrete to provide a corrosion resistant solution. The end result was a faster, lightweight install, with stairs that won't corrode again when they are exposed to the coastal environment.

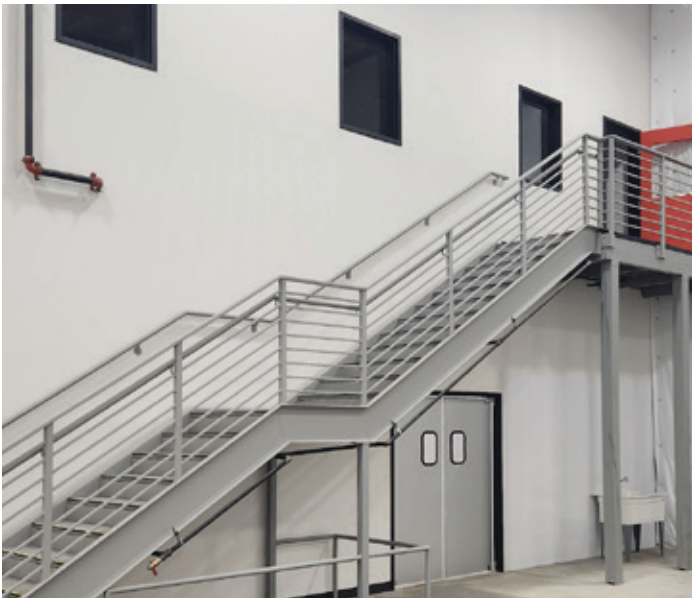
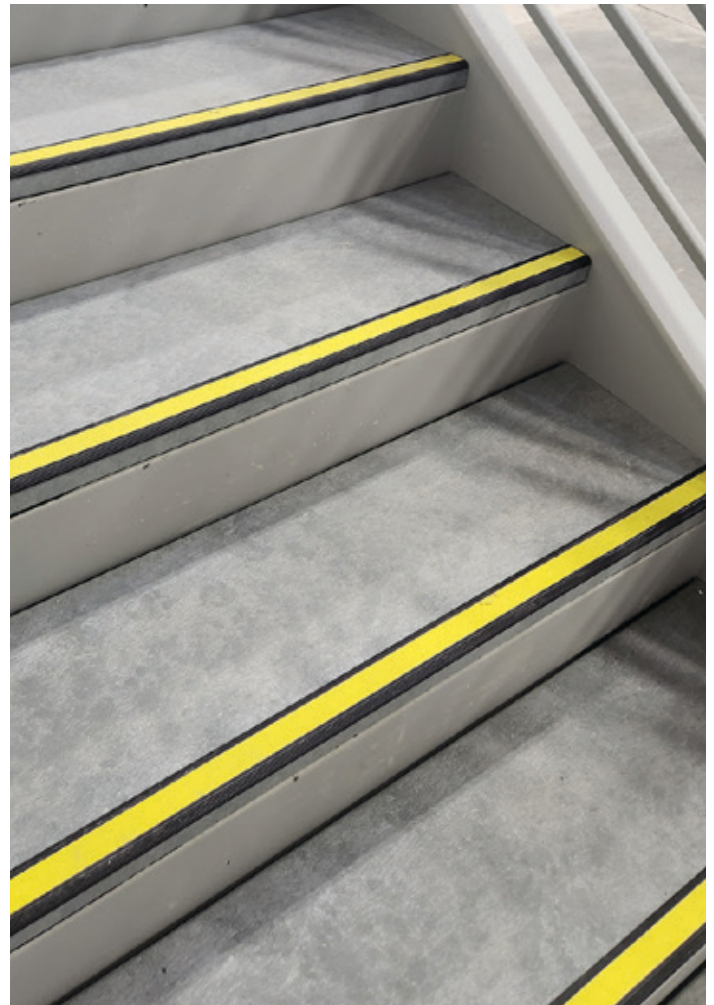
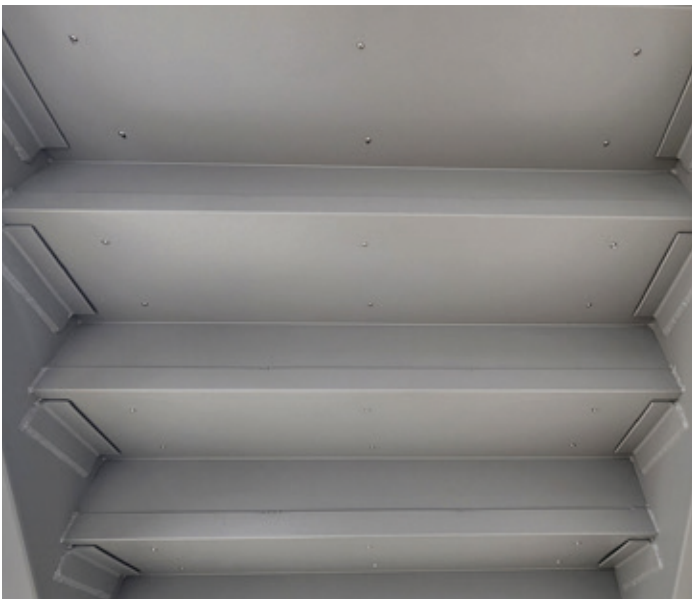
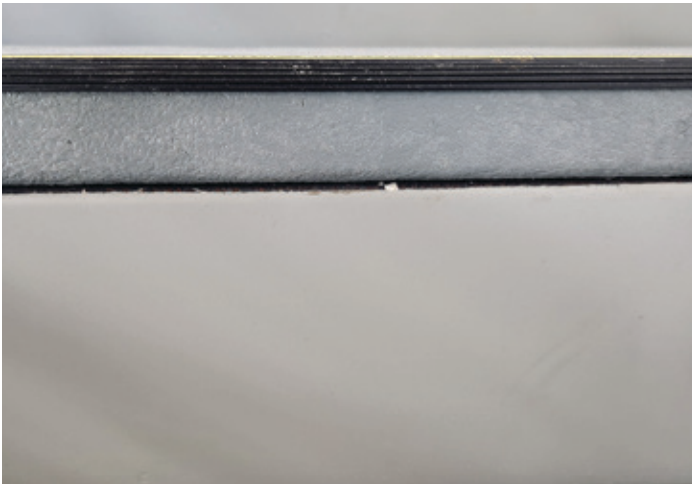
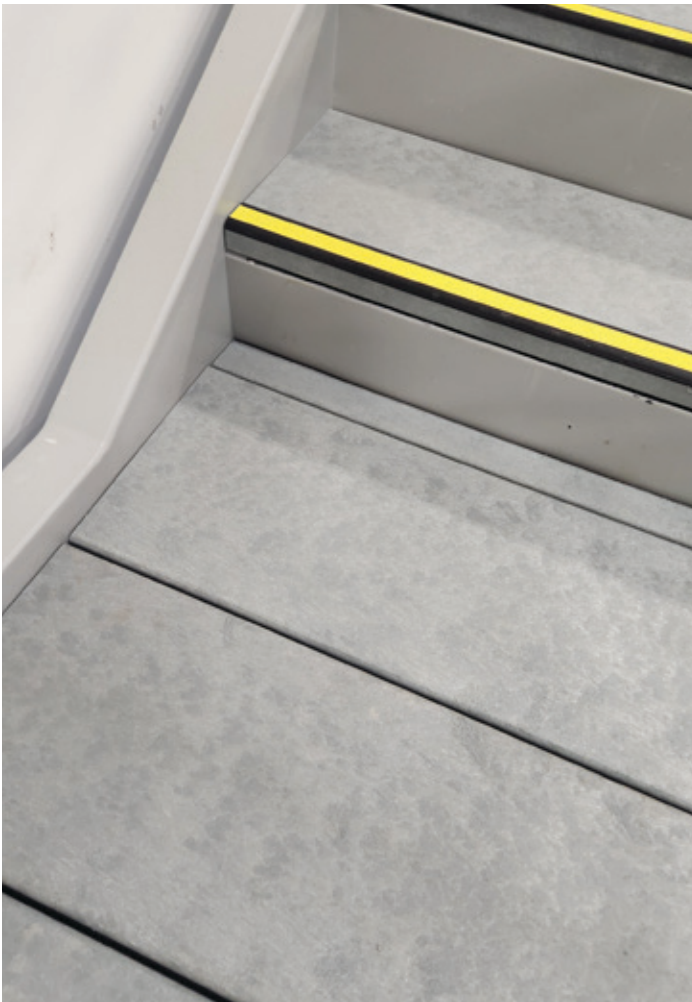
Perma-Tread was selected because of immediate availability, no loss, cost savings, no maintenance, non-corrosive properties, and for long lifespan as an alternative to precast concrete treads.

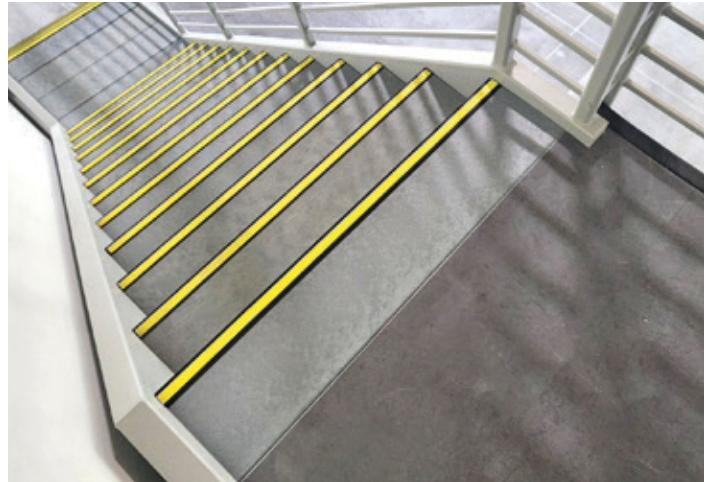
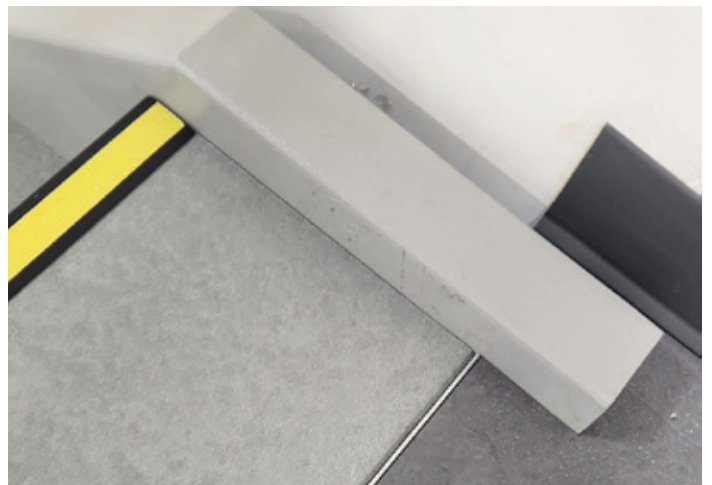
OREGON - WAREHOUSE OSHA STAIRS

Interior Application

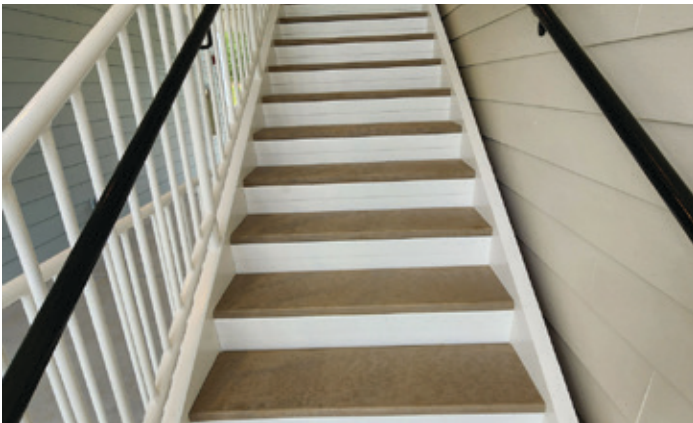
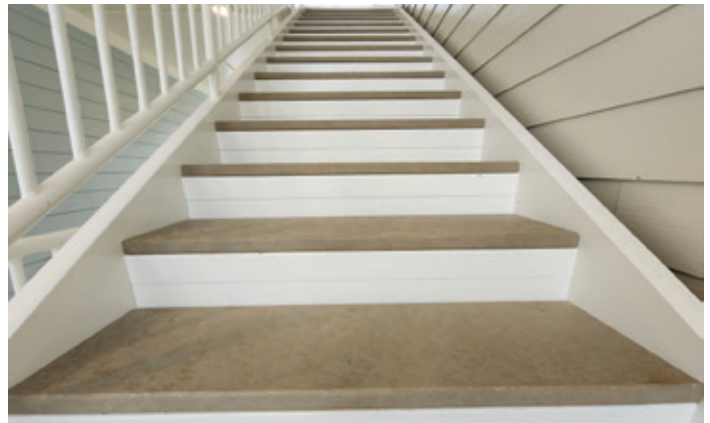
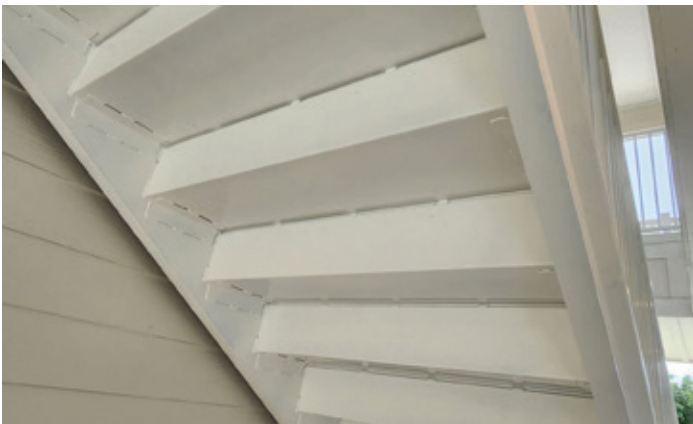
A new 150 apartment unit project with 26 stairways. The metal stairs we've fabricated with metal flat pans to accept Perma-Tread 212 as an instant alternative finish to precast concrete treads. The selected color was Weathered Concrete to resemble a traditional concrete look. Perma-Tread offered a lighter weight solution which greatly saved freight and installation costs. Perma-Tread was selected because of immediate availability, no loss, cost savings, no maintenance, non-corrosive properties, and for long lifespan as an alternative to precast concrete treads.

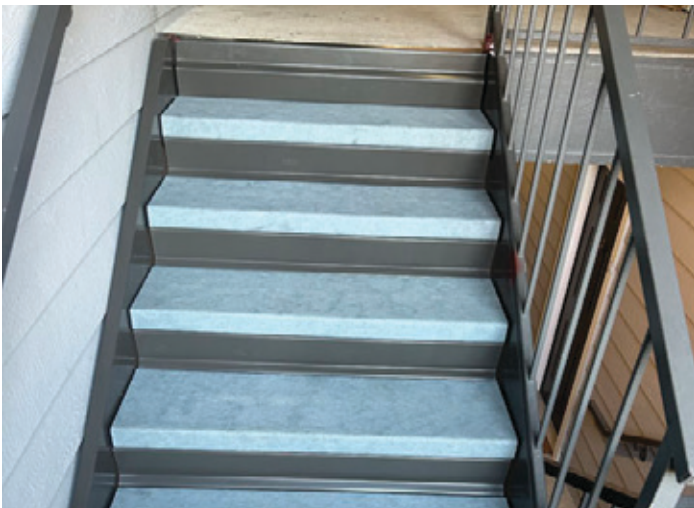
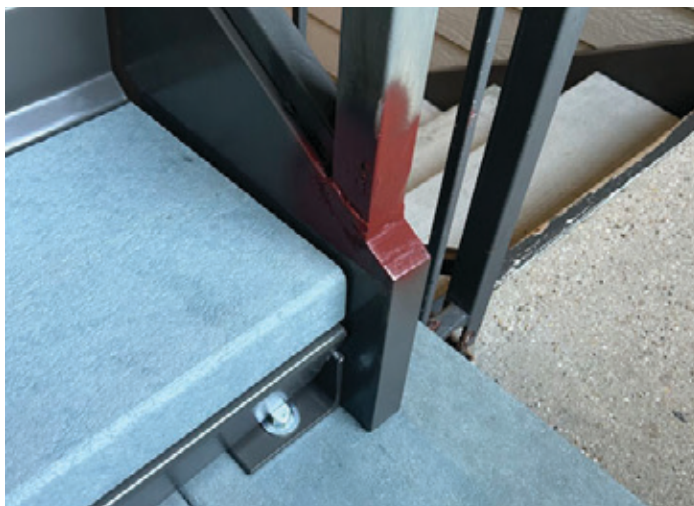
The original metal stairs of this existing apartment home complex were protected from the elements; however, concrete filled landings and precast concrete treads deteriorated over the years due to the humid climate. Perma-Tread 312 wet cement was selected as an alternative replacement solution to concrete. Perma-Tread was selected because of construction cost savings, free-span structural characteristics, no maintenance requirements, and non-corrosive properties.

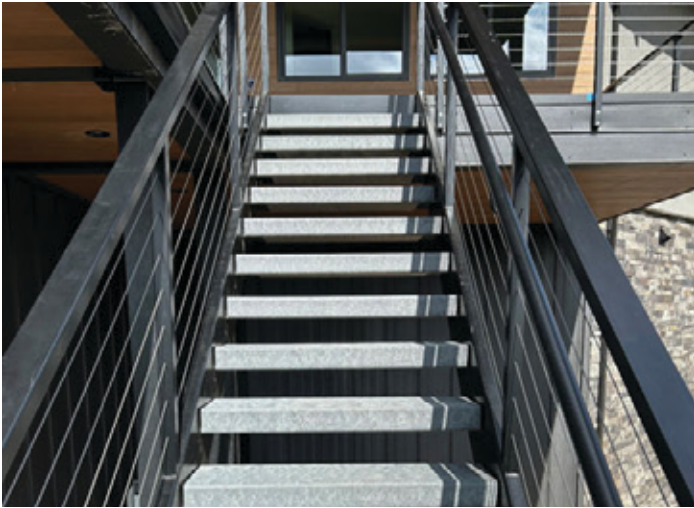
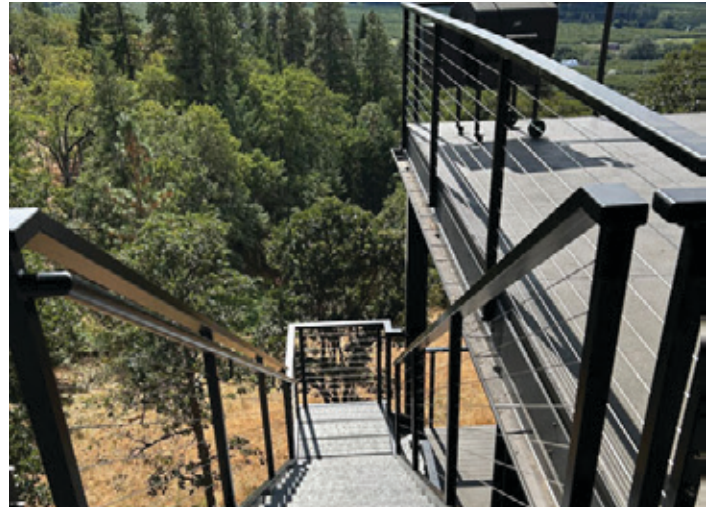
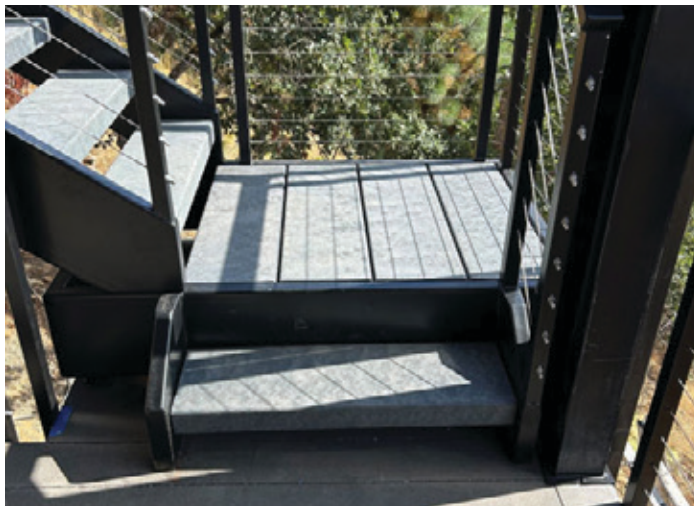
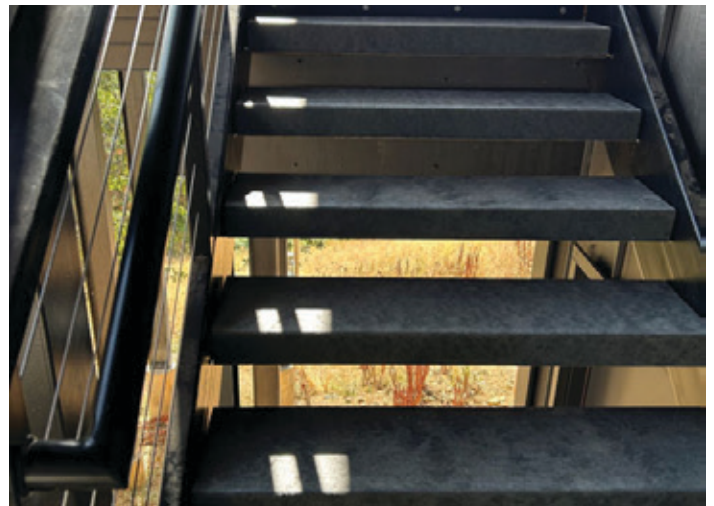
This new residential deck stair was originally designed for open riser precast concrete treads. When weight and durability of concrete became a concern after the metal stair structure was installed, sourcing concrete treads became an issue for the homeowner. Perma-Tread 412 Dark Gray was selected as the final solution. The material was cut to size on site with ordinary tools and installed like lumber. Free spanning between stringers attached to seat angles from underneath.

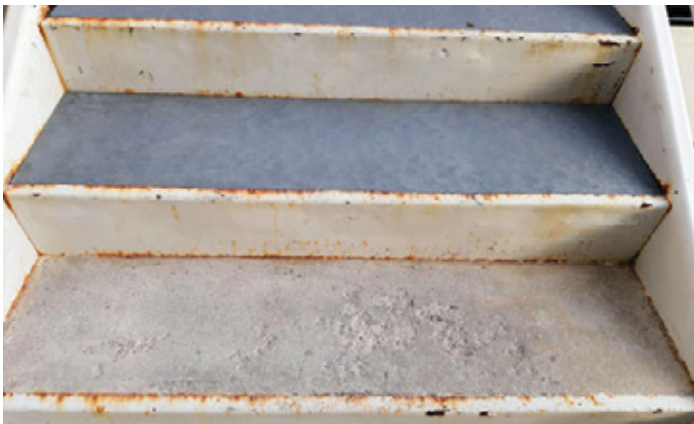
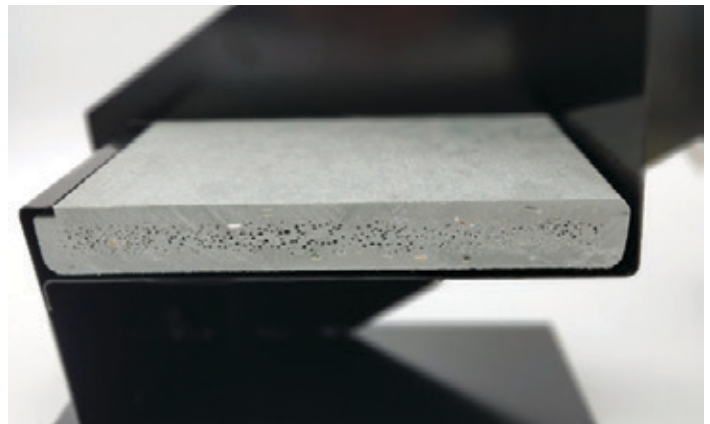
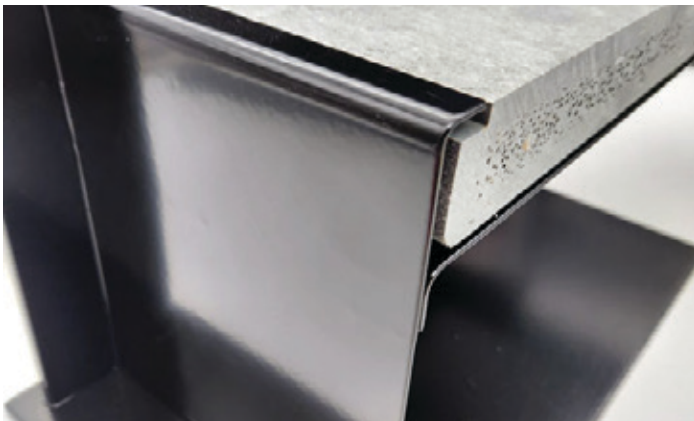
A food processing facility needed to repair their exterior metal pan filled stairs to resolve safety concerns created by concrete corrosion. Concrete was removed from the stair pans. Perma-Tread 212 Wet Cement was selected. Cut to size on site, modified to fit the metal pan, and dropped in for an instant finish creating a better result that will not corrode again.
